Axis Controller Not Responding to NC Alarm

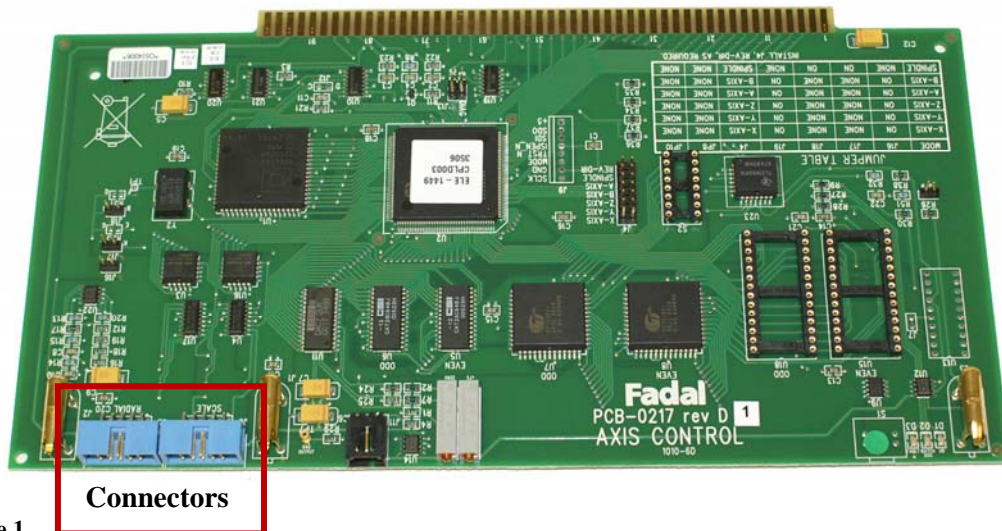
Figure 1

This is a typical alarm on your 1010 cards when they begin to fail or the 1060 motherboard is not passing the signal to the processor.

1. With the power off to the machine, reseal the card.
2. The connectors on the front of the card (see Figure 1), may have become loose so you'll want to reseal them.
3. If all else fails, replace the card with a new one. The part number you will need is PCB-0217.
