“Waiting on Air Valve” Alarm

This is a common alarm with an easy fix. This alarm means your High/Low Roller System is trying to change gears, but the switches are not reading back to the control.

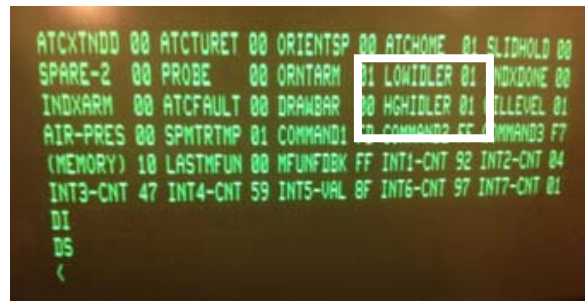
Figure 1

As you can see in this example (see Figure 1), the Low Idler is engaged and the higher roller is not. With the S.1 and S.2 commands in MDI, you should be able to see the states change from one to zero and zero to one.

A very common reason for this alarm is simply forgetting to turn the air on for your machine. Other than no air to the cylinders, the alarm would have to be due to either the 1040 Mill Interface card or a bad switch in the Idler unit.

The upper switch is a Hall Effect switch and the lower switch is a Reed switch, so you’ll want to know which you have before you order the replacement. We stock them all.
